Case 281 : Narrative

Case Vehicle (A): 1998 Jaguar	Vehicle (B): 1999 Ford
Type: Vanden Plaus, 4-door sedan	Type: Explorer Sport, 4 x 4, 2-door SUV
Driver: 48-year-old female	Driver: 69-year-old male
CDC: 12-FYEW-1	CDC: 99-0000-0

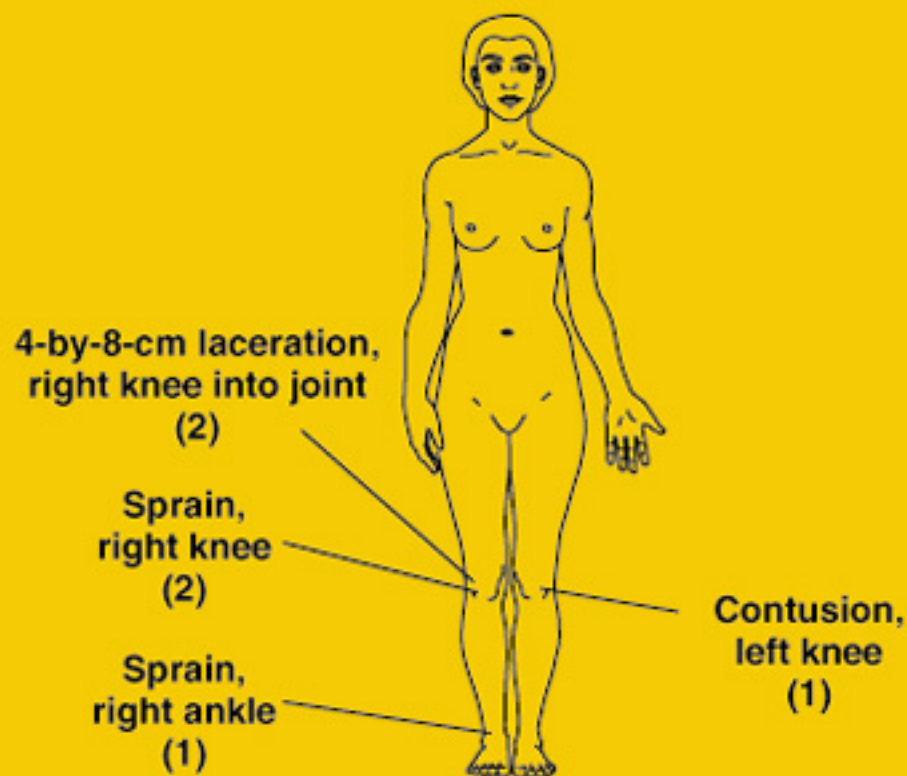
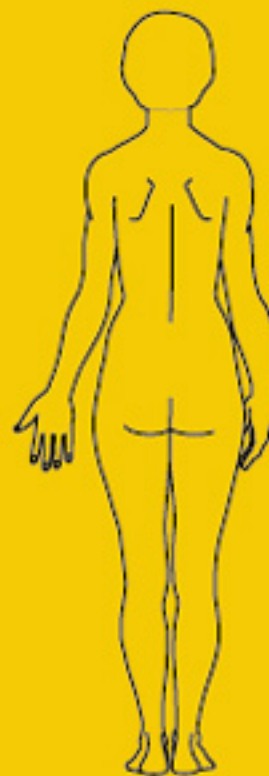
CASE NO.: 281-01

On impact, the driver moved forward relative to the vehicle interior. Her face contacted the airbag, [46](#) as evidenced by the lipstick on the airbag fabric. She sustained a contusion to the left knee, due to contact with the knee bolster. She sustained a 4-by-8-cm laceration into the right knee joint, and a sprain to the right knee, due to contact with, and [47](#) [48](#) [49](#) cracking of, the plastic cover under the steering column. She sustained a sprain to her right ankle due to braking.

Occupant: Driver	Age: 48 years	Gender: Female		
Restraints: 3-point belt not worn; frontal-impact airbag deployed,	Stature: 163 cm (5 ft, 4 in)	Mass: 86 kg (190 lb)		
Injury Description	A.I.S.	Injury Source		
—	—	Definite	Probable	Possible
4-by-8-cm laceration, right knee into joint	2	Plastic cover under steering column	—	—
Sprain, right knee	2	Knee bolster	—	—
Sprain, right ankle	1	—	Brake pedal (braking)	—
Contusion, left knee	1	Knee bolster	—	—
Maximum A.I.S. Level	2	—	—	—
Injury Severity Score	5	—	—	—

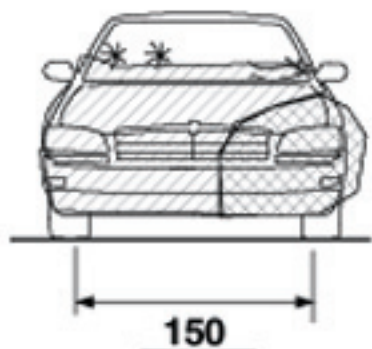
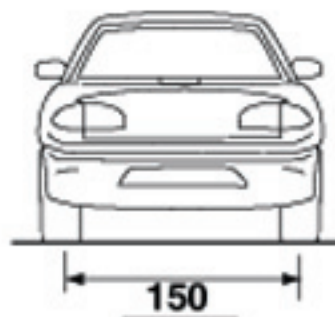
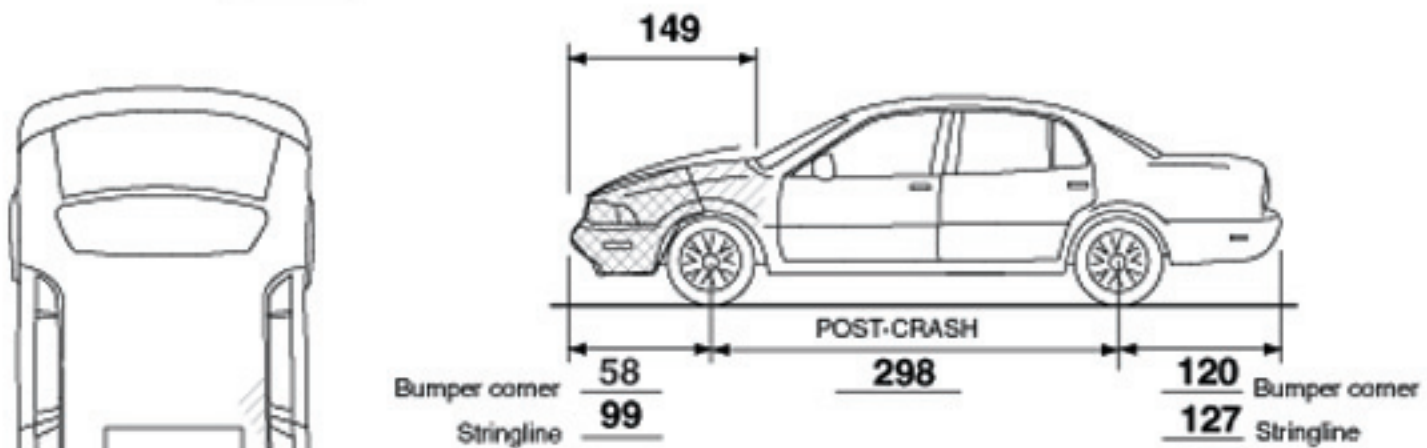
Max. crush
to left front
bumper corner

[3](#) Damage to case vehicle (A) was moderate. [4](#) Direct damage began at the left-front bumper corner and extended 84 cm to the right, resulting in 52-percent vehicle overlap. The maximum crush was 27 cm, at the left-front bumper corner.

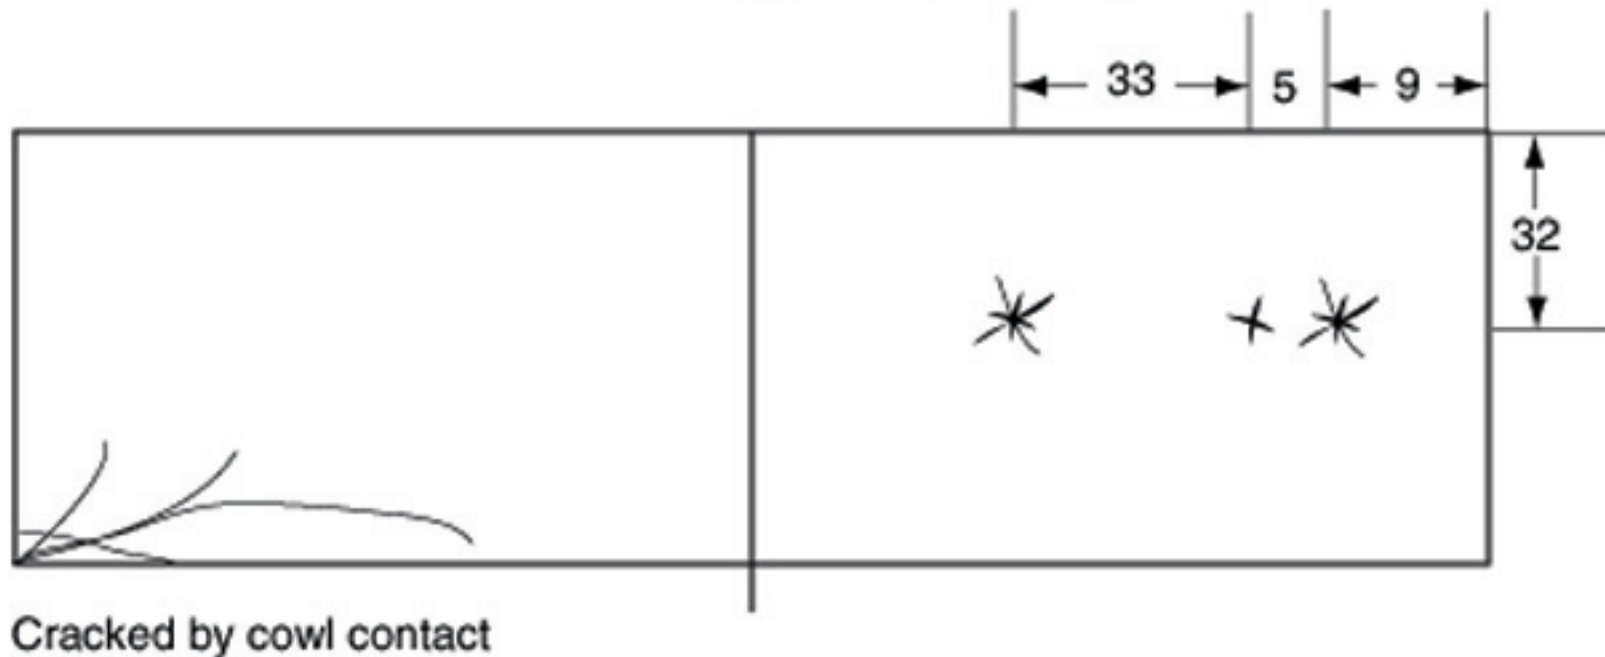
Windshield starred by passenger airbag module cover contact

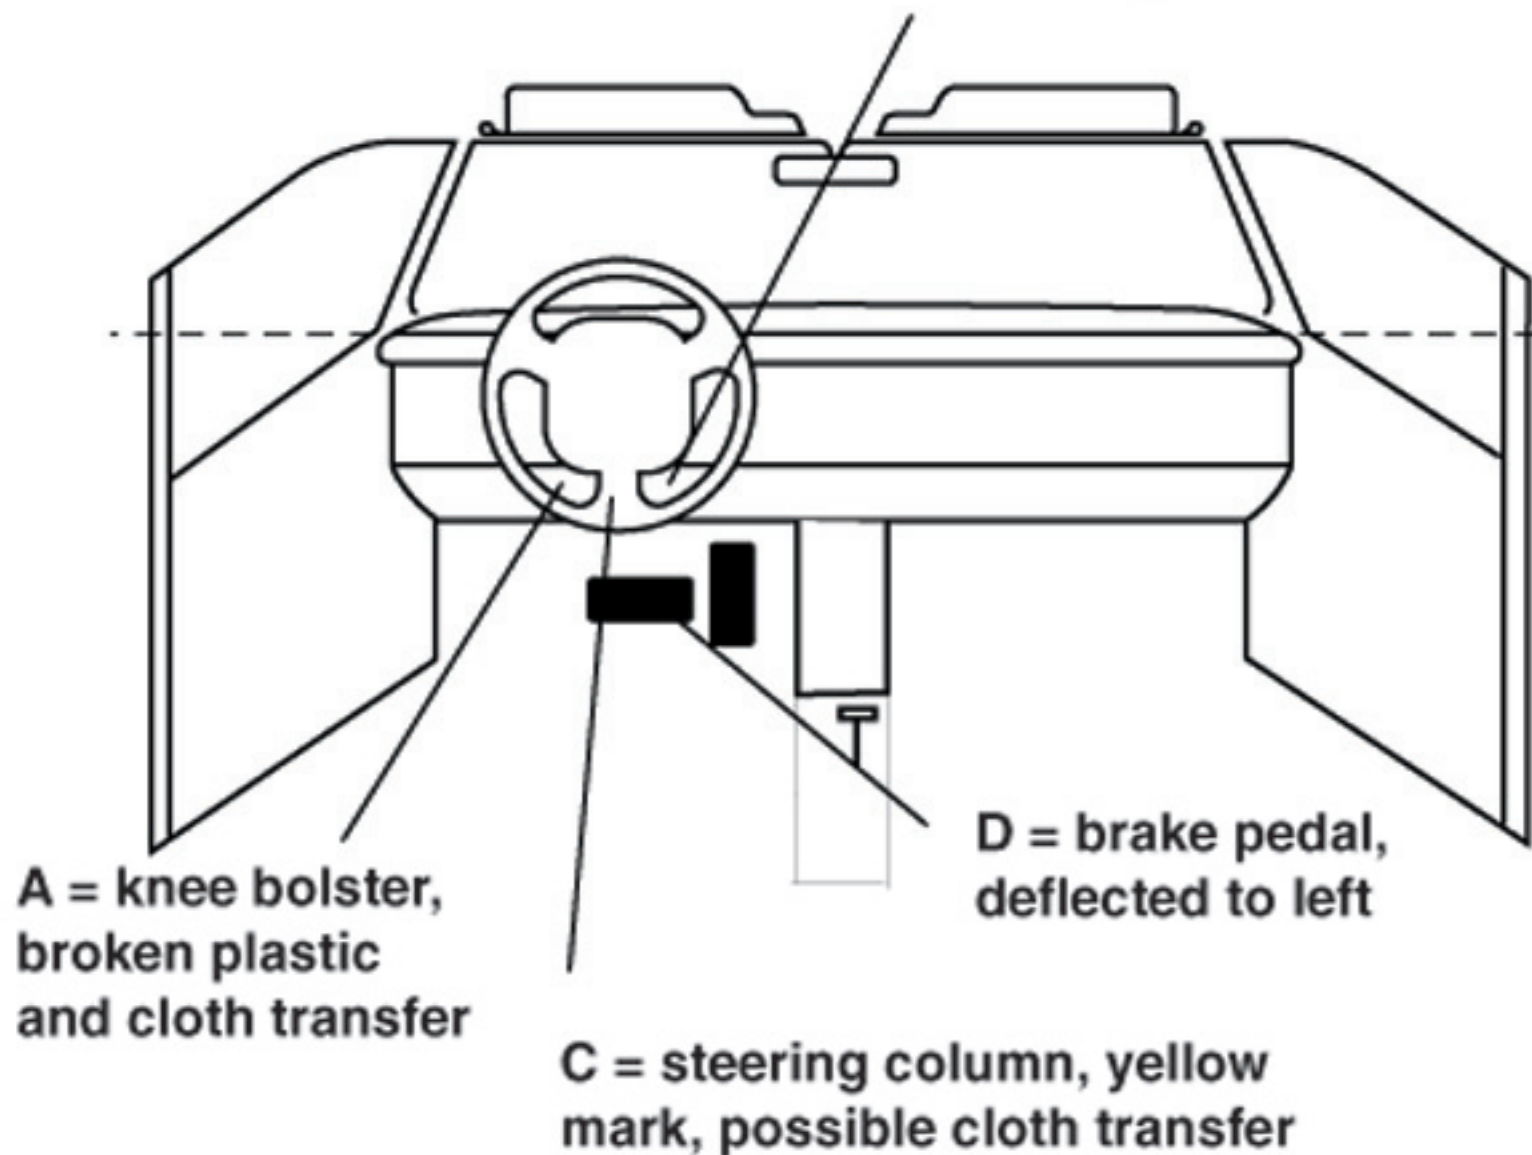
**B = knee bolster,
broken plastic**
